Condition of Abodo Thermally Modified Timber Test Samples After Up to 94 Months (~7 ¾ Years) Outdoor Above-Ground Exposure.

30 April 2025

Jeanette Drysdale
Wood Protection Consultant

Abodo Wood Ltd
62 Ascot Road, Mangere Auckland

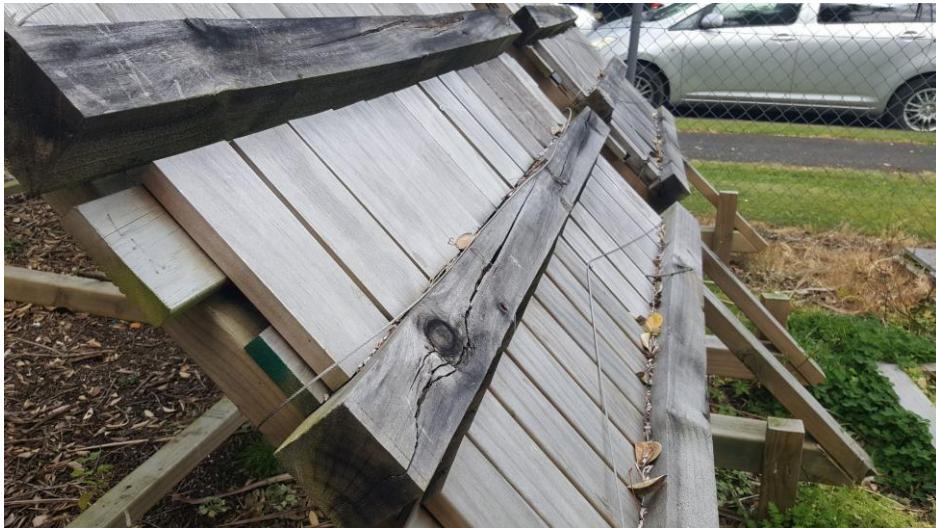
Flat panel racks (September 2018)

The support panels on the frame at previous and latest inspection showed signs of significant decay and active fungal mycelium, and was a source of inoculum contributing to a high potential decay hazard. Decayed support frames were previously replaced in June 2020.

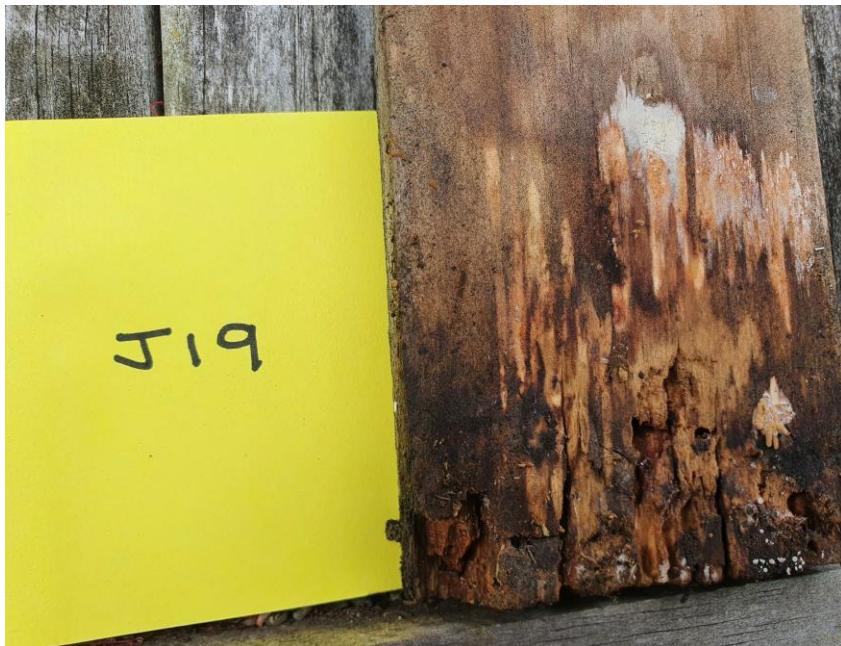
After 94 months exposure, the untreated samples (Set J) are decayed. Untreated Radiata pine has a durability class 4 (perishable) and expected above ground life expectancy of less than 7 years¹. The results from this flat panel trial indicate this test exposure method and

Samples typically will show decay well advanced from the bottom of the sample edges in contact with the panel rack.

Untreated Radiata pine extensive decay across the cross-section at 67 months

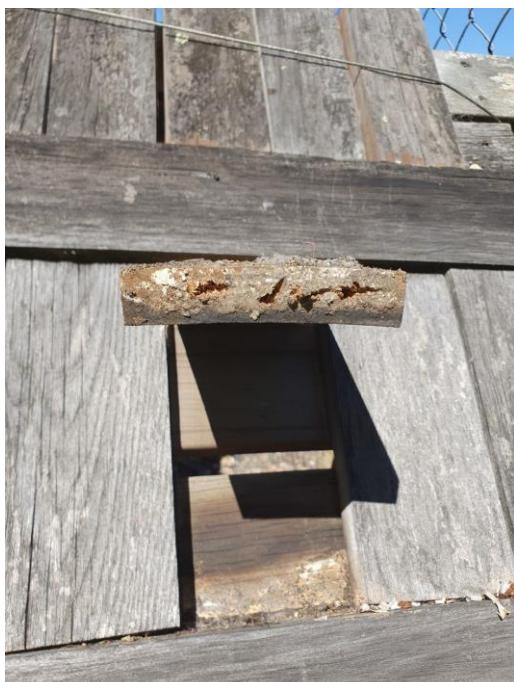
After 94 months, the untreated heartwood sample decay ratings vary from 0 (decayed) to 9 (decay <3% of cross-section). There are white/bleached flecks/streaks on sample surfaces indicating signs of white rot, and some decay of edges originating from the supporting frame. This highlighted that there may be more severe decay within the samples that is not always visible or identifiable from the surface.

***Eucalyptus grandis* decay sample after 94 months**

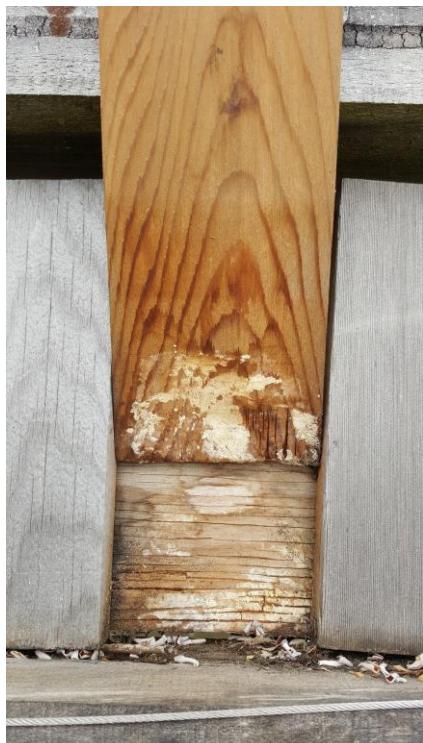
The decay ratings vary, from 0 (decayed) to 9 (<3% cross-section decayed) and from the bottom of the test sample. The fungal degradation appears to be a consequence of decay establishing in the back-support panel for the test samples. The assessments at 94 months show a significant increase in decay establishment from the previous assessment.

Western red cedar decay on back of sample and supporting panel/rack (17 months exposure)

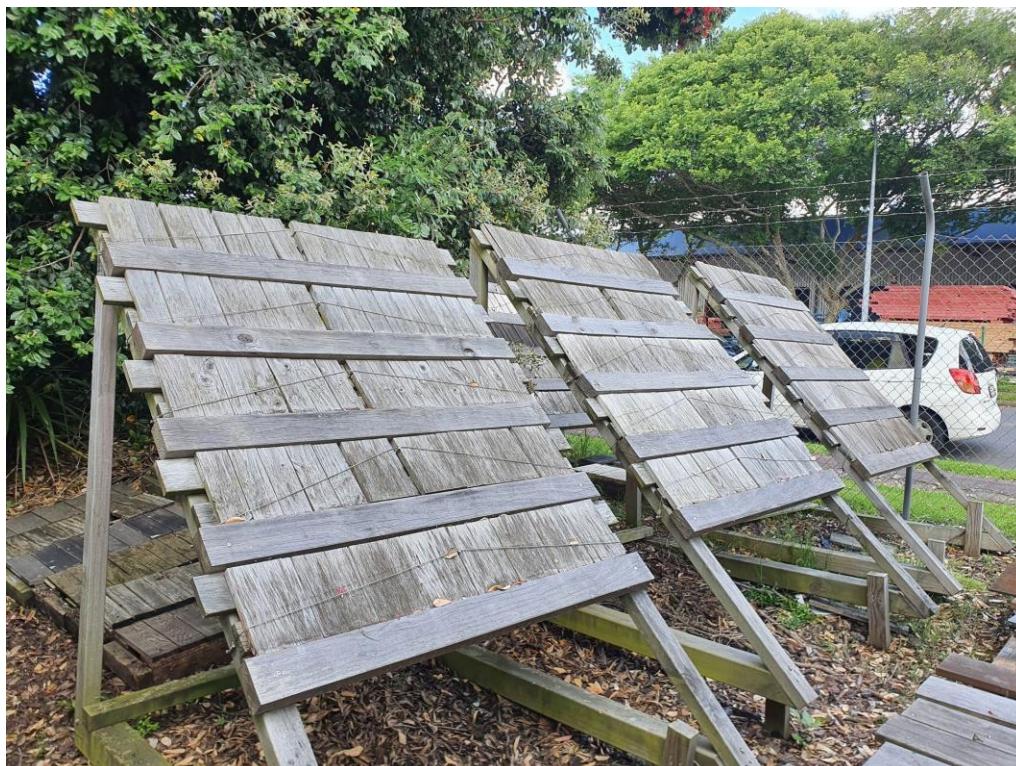
A-frame racks after ~ 67 months exposure (December 2022)
