**Cross cut adhesion test to Abodo timber section.**

Purpose of this test was to provide the indicative adhesion performance of Remmers coatings to 'Abodo' timber samples provided by Timbmet. Abodo is a trade name of thermally modified Radiata Pine. Remmers product LW-718 tinted RC-790 was selected for the purpose of this test.

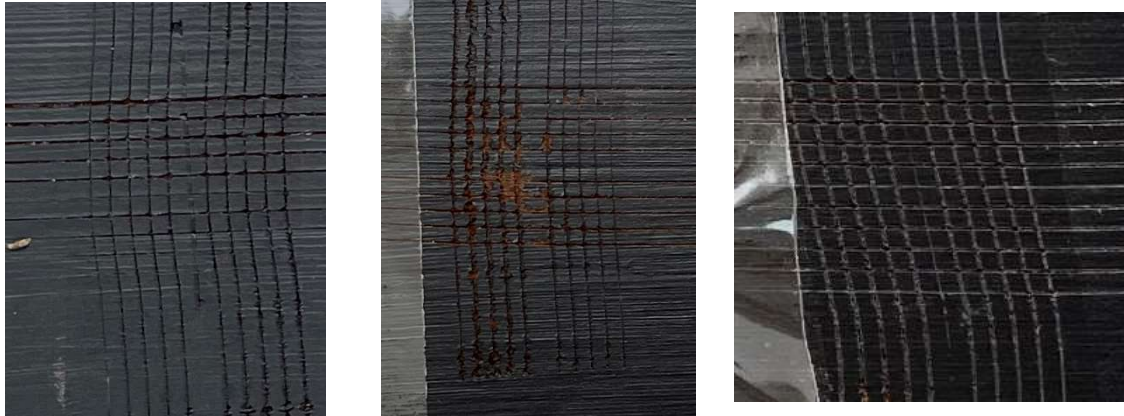
Three separate cross hatched area were tested. Cross hatched on dry coating / cross hatched on wetted area / cross hatched then wetted. For the purpose of this indicative test, wet paper towels applied for 3 hours. The cross cut adhesion test was carried out with 2mm spacings and tape with an adhesion to steel rating of 4.3N/cm

Small area of delamination along edges or at intersections is evident due to the weakness in timbers surface structure. (common with thermally modified timber). On the whole good results. ISO class 1/2.

All cross hatched areas have adequate adhesion results with no excessive detachments of concern. Providing the Remmers coating system is adhered too, there is little cause for concern and comparable to coating other cladding timbers. External long exposure weather testing is now recommended.
